# LONG-TERM CF6 ENGINE PERFORMANCE DETERIORATION - EVALUATION OF ENGINE S/N 451-479

W. H. Kramer and J. J. Smith

General Electric Company  
Aircraft Engine Group  
Cincinnati, Ohio 45215

Prepared for  
NATIONAL AERONAUTICS AND SPACE ADMINISTRATION  
Lewis Research Center  
Cleveland, Ohio 44135  
February 1978  
Contract NAS3-20631

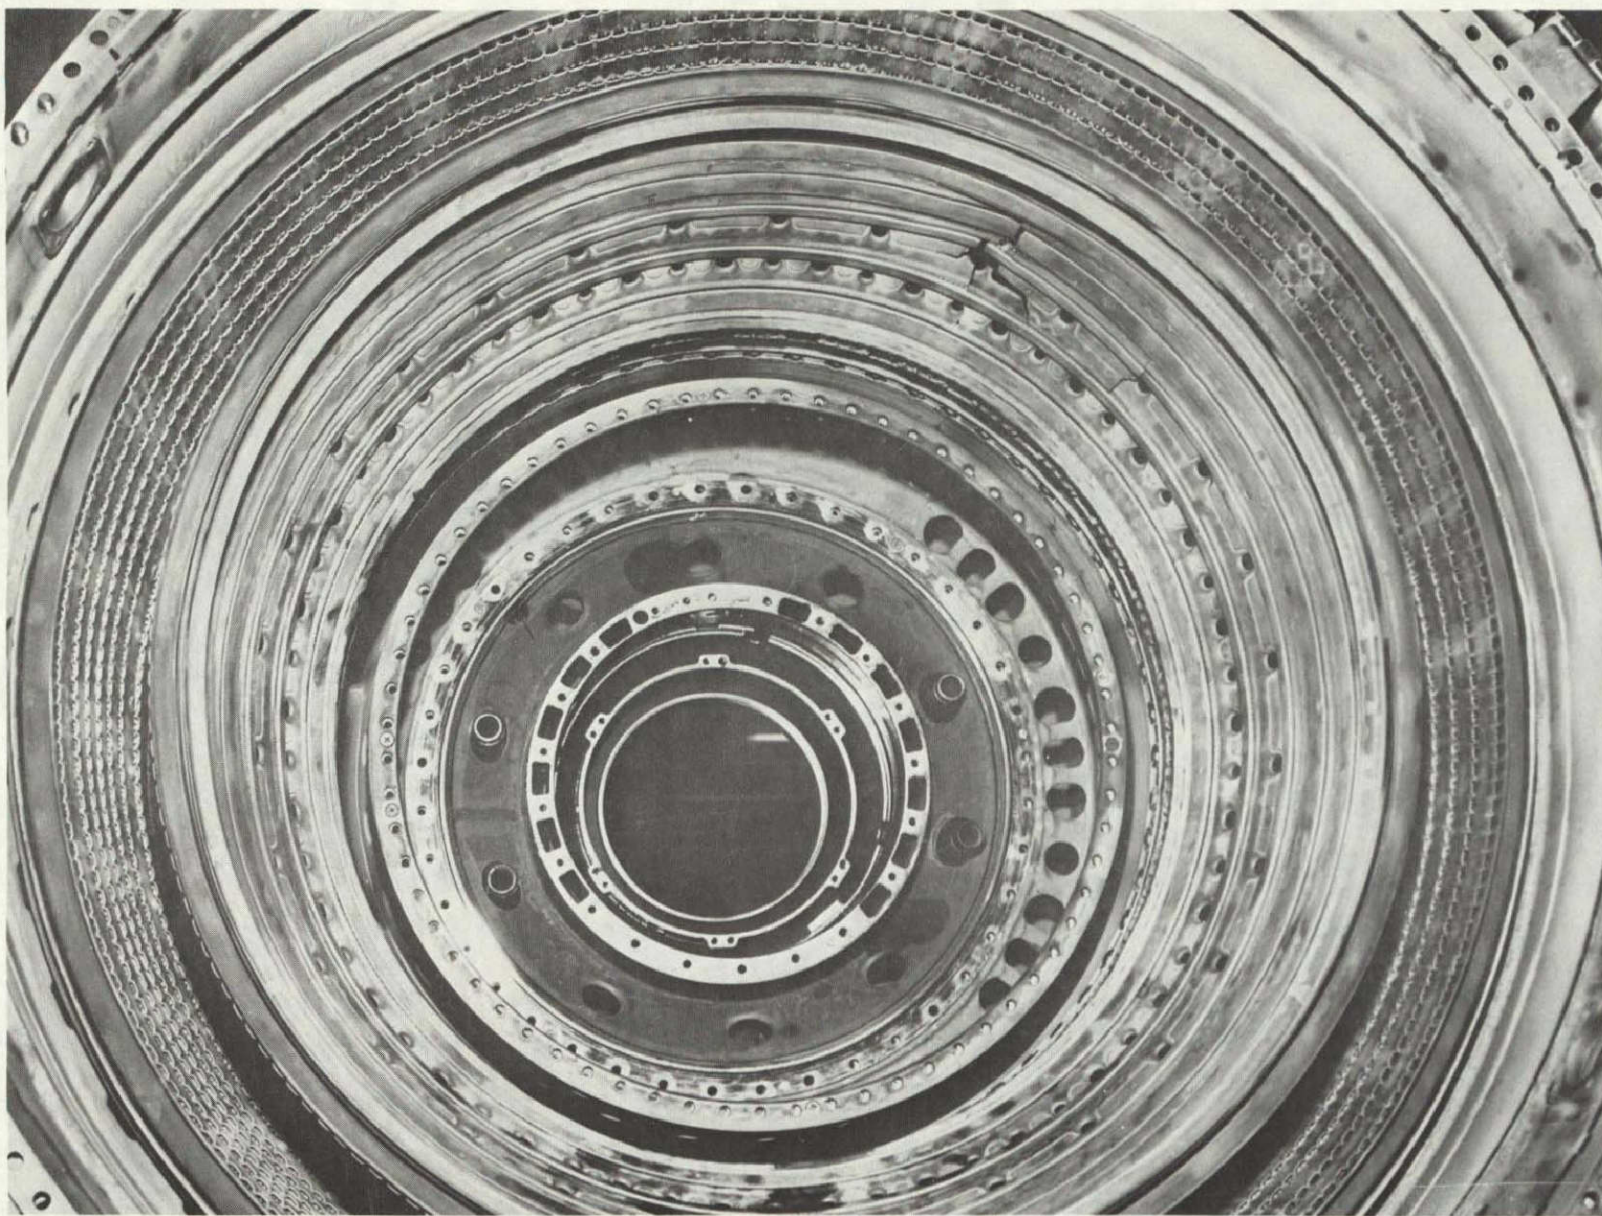
To expedite the work scope, the combustor was not removed from the rear frame, but rather visually inspected as installed. The combustor had its typical 1/4" to 1/2" cracks, inner and outer liners. The most noteworthy fault was the cracks originating at the inner liner's aft thimble louver at approximately the 7 o'clock location. This particular louver had cracked in four different directions of varying lengths (Figures 8-6 and 8-7 in Appendix B). The cracks were approximately 5/8", 1", and 2-1/2" in length and another about 2-1/4" long connecting with a 4-1/2" circumferential crack. The whole piece was bulged into the airstream approximately 5/8". There were six more of these thimble louvers with cracks ranging from 1/2" to 1-1/4" but these are considered insignificant with regard to performance.

Figure 8-6. Combustor, Overall Cracks.

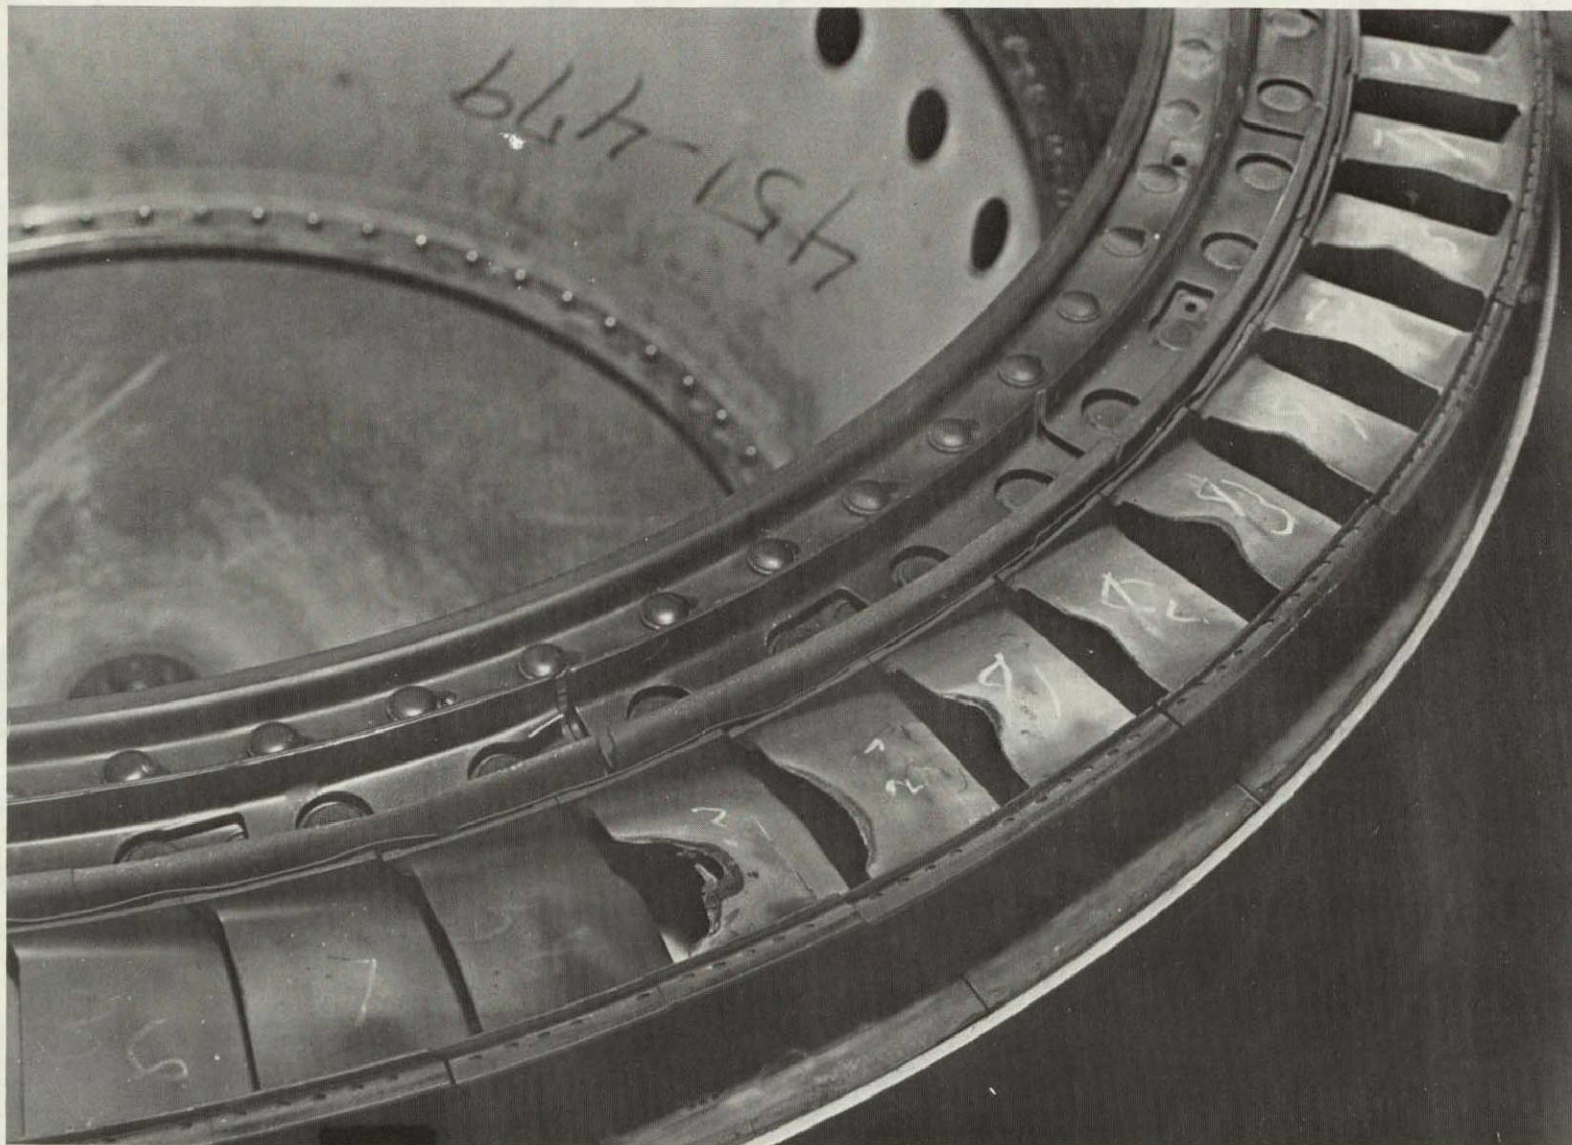
Visual inspection of the Stage 1 HPTN assembly revealed 13 vanes with some degree of burning on the trailing edge, while some 10 other vanes were bowed in the same area. (See photographs in Appendix B, Figures 8-10 through 8-13. Note that the position markings as viewed in the photographs are incorrect. Per B/P, the vane marked No. 18 is really Vane No. 1. From that point, the vanes should be marked in clockwise order. For orientation purposes, all references to vane position numbers in this report are per the actual position and not as depicted in the pictures.) As can be seen in the photographs, all vane distress emanated approximately from the center of the airfoils at the trailing edge, and continued radially outward and inward about the same amount for each particular vane.

All of the vanes that experienced the burning/distortion showed radial cracks of varying lengths on the concave side, depending on the severity of the distress. These cracks were located  $3/8$ " to  $1/2$ " forward of the trailing edge.

Figure 8-11. Stage 1 HP Turbine Nozzle Assembly, Trailing Edge, Burnt/Distorted Vanes.
